### RETAINING WALL - PADDINGTON

**Date of Project:** 7 December 2017

**Location:**  
138 Boundary Rd,  
Paddington NSW

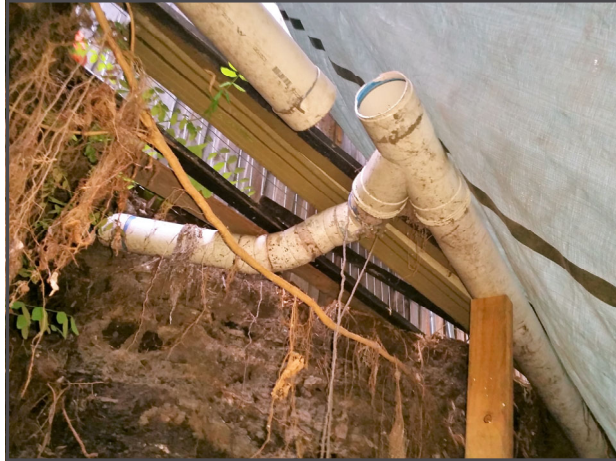
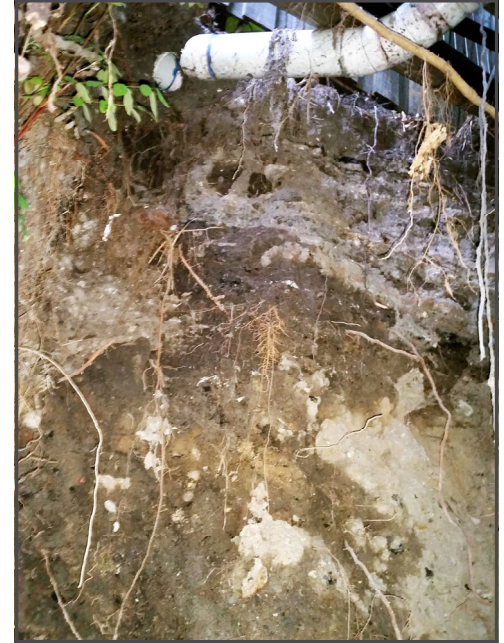
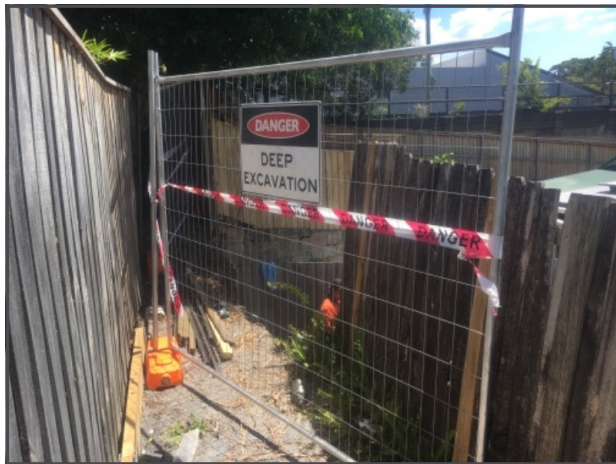
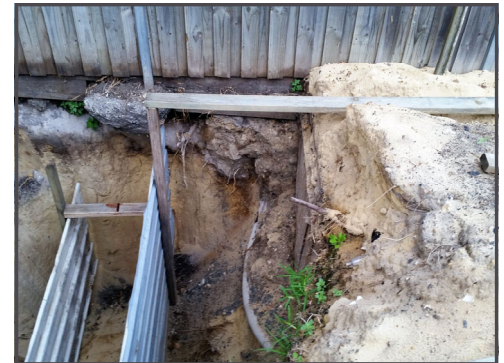
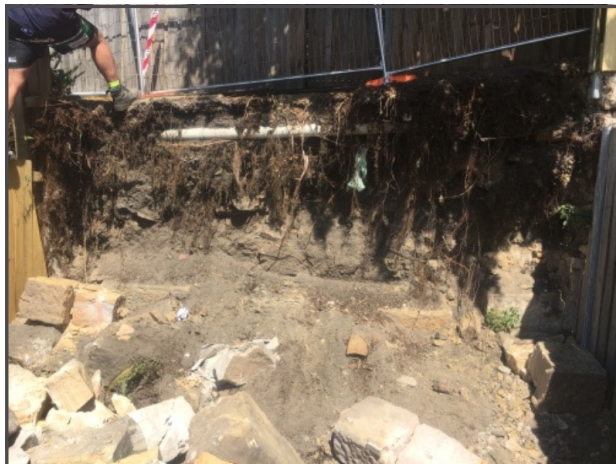
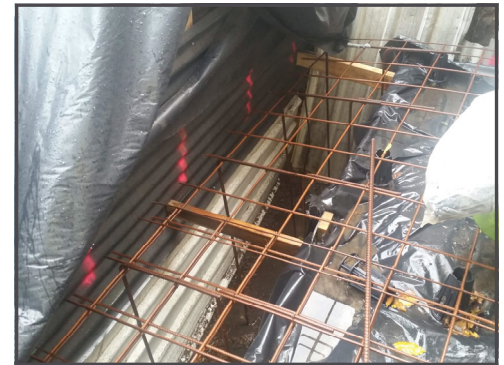
Work had to contend with broken pipelines, loose sandy fill and poor weather conditions.

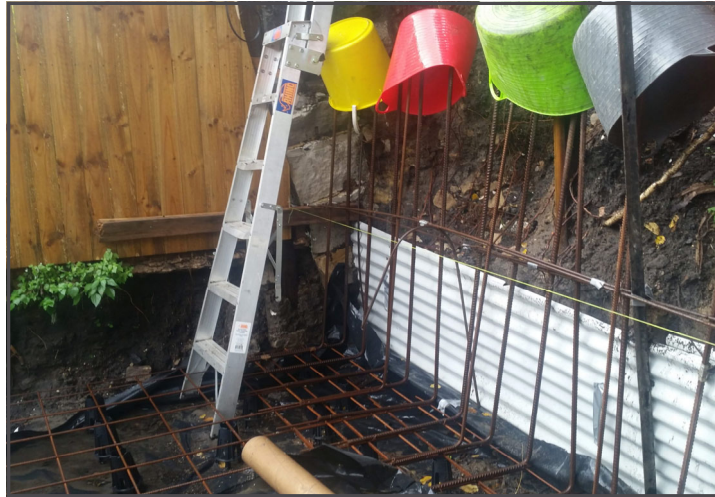
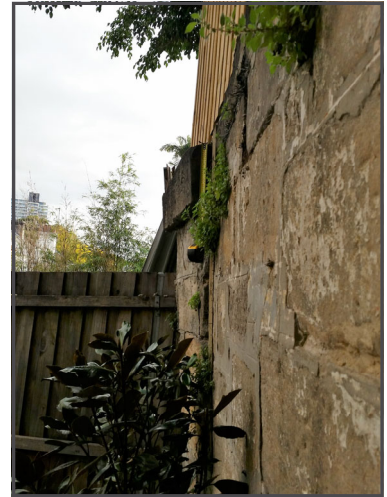
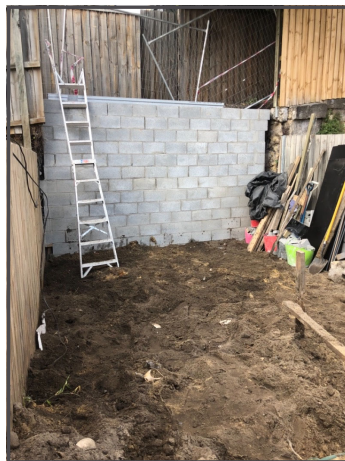
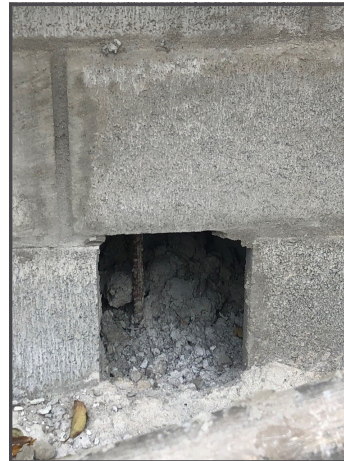
Reinforcing, clear-out openings in the block works, original wall lean can be seen at the top right photo.
