HOUSE ADDITIONS - BEROWRA HEIGHTS

Date of Project: 7 January 2020

Location:
46a Lonsdale Avenue,
Berowra Heights

Ref: 220102

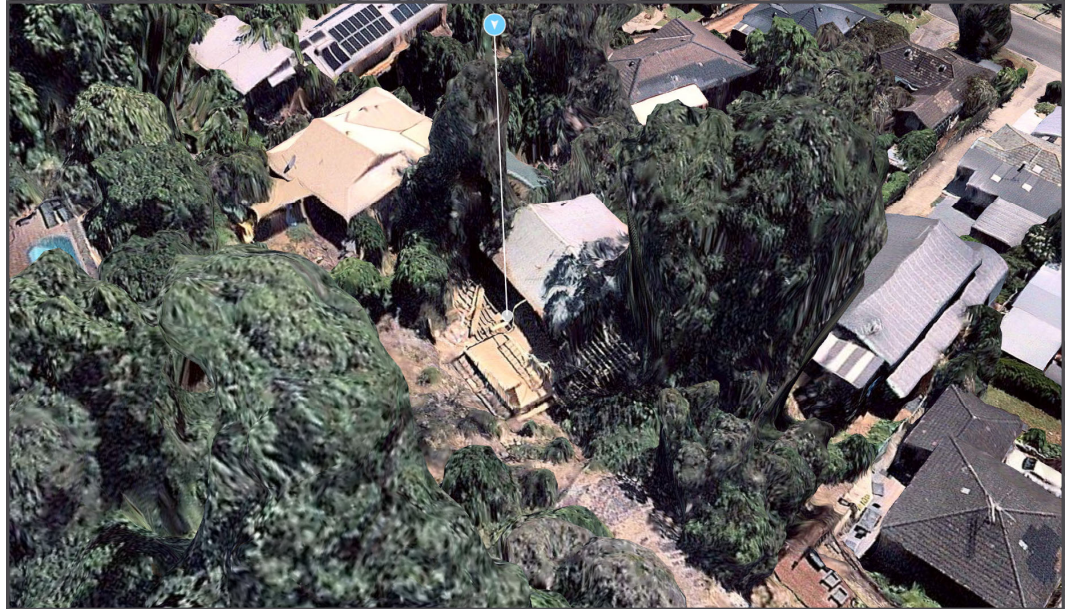
FTS was commissioned to design a retaining wall and stair access to the double garage with slab, services adjustments, assess slope stability and bearing strength of the steep rocky slope and design the house framing for the additions. FTS also provided access plans to the garage for Council approval because of the shared access on this battleaxe block shared with three other properties. Roof and site drainage were also detailed.

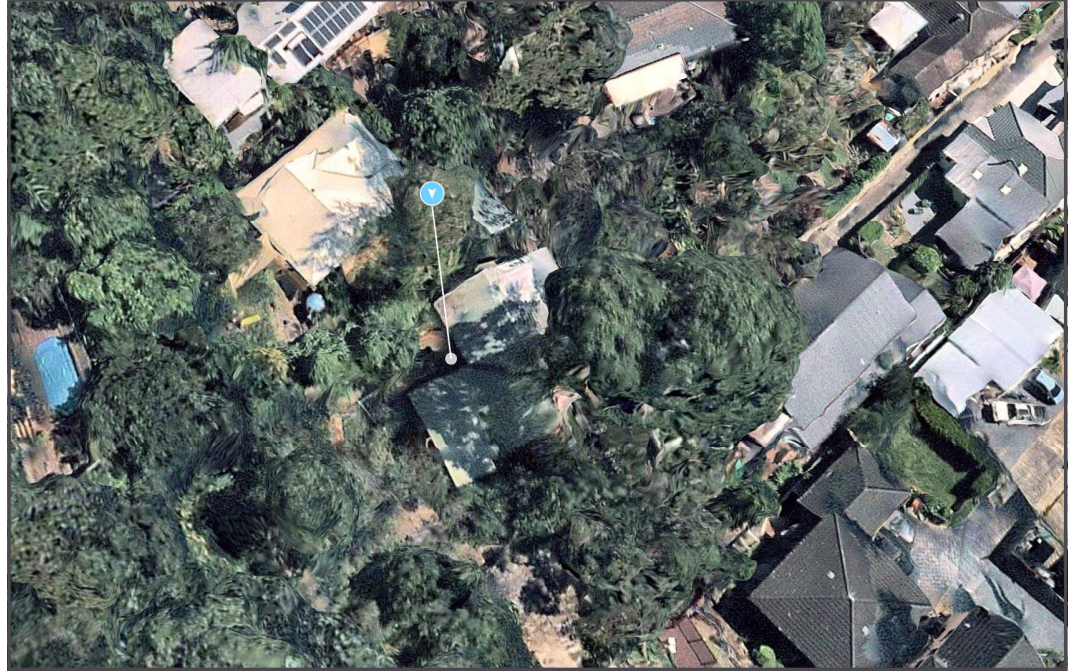
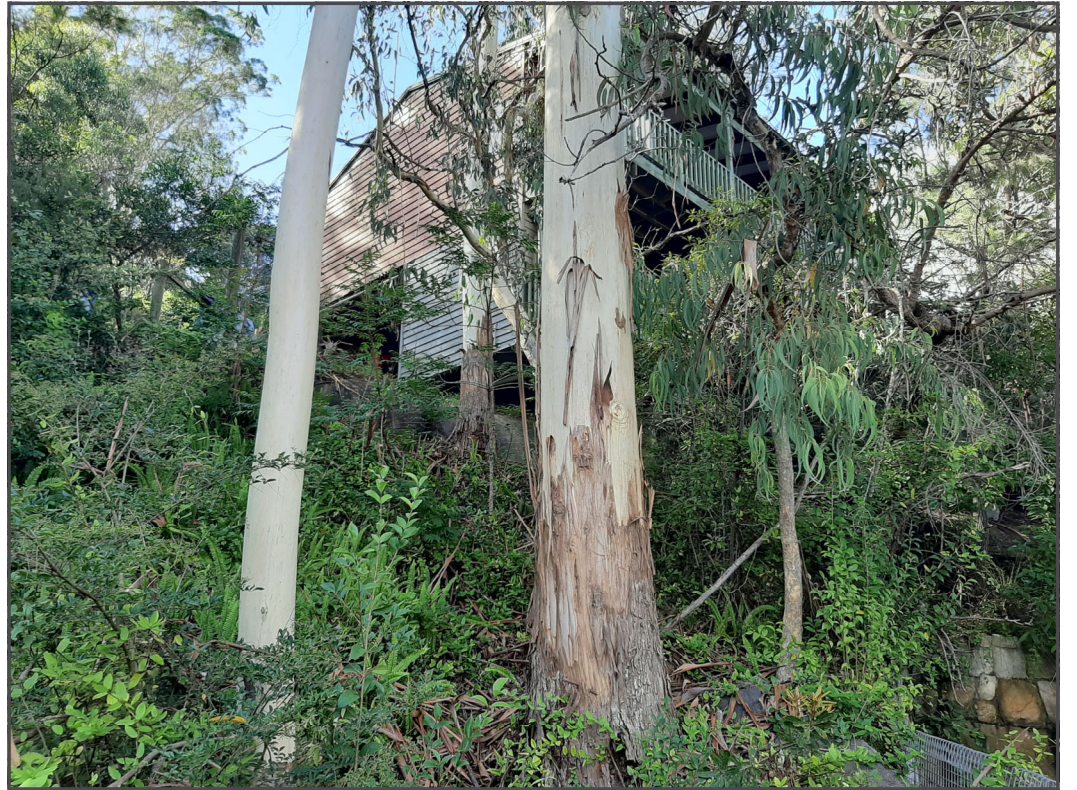
Slippage, poor connections, splitting,
dislocation and separations all contrib-
uting to the roof sagging and leaking.

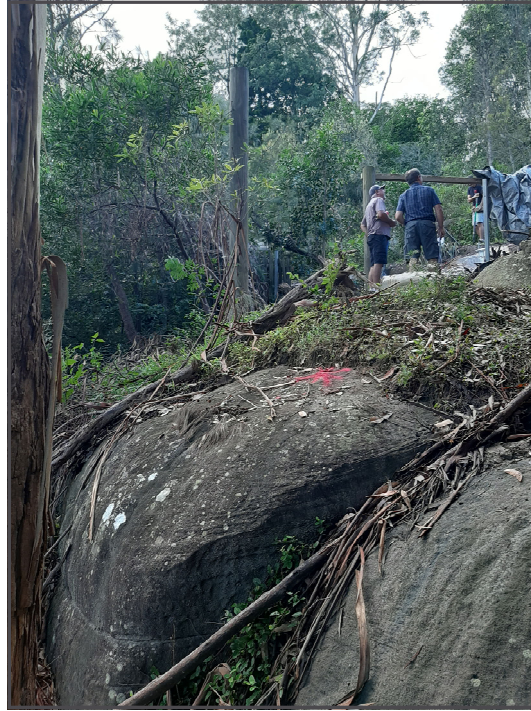
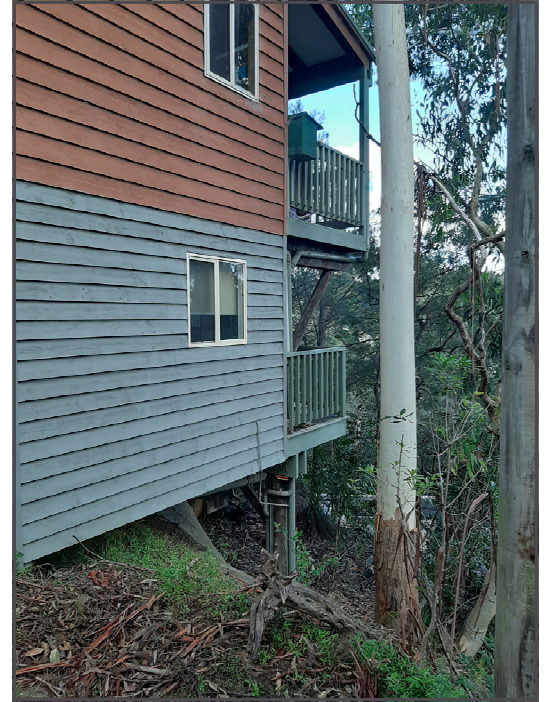
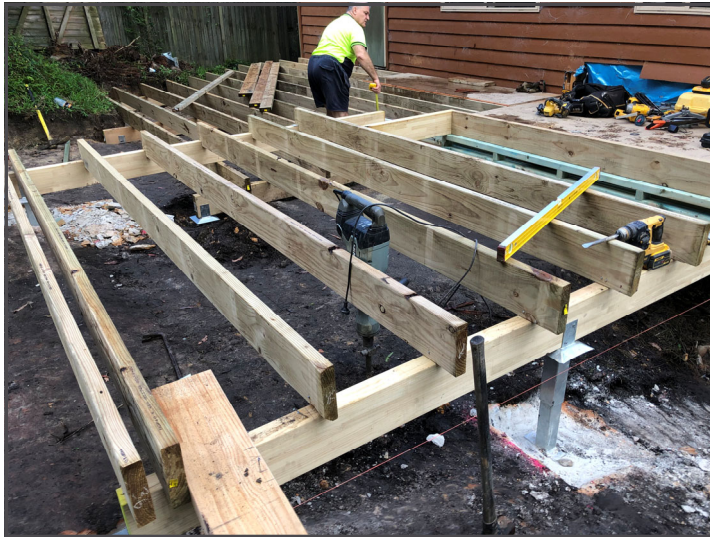
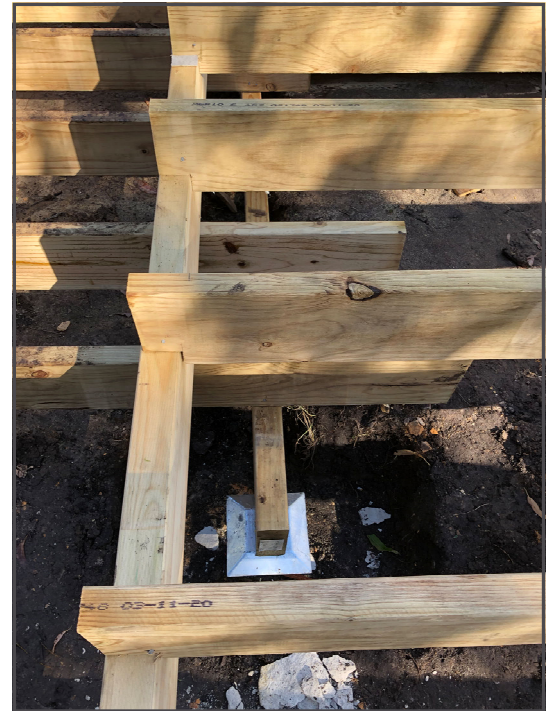
FTS designed and inspected all the timber framing and foundations..

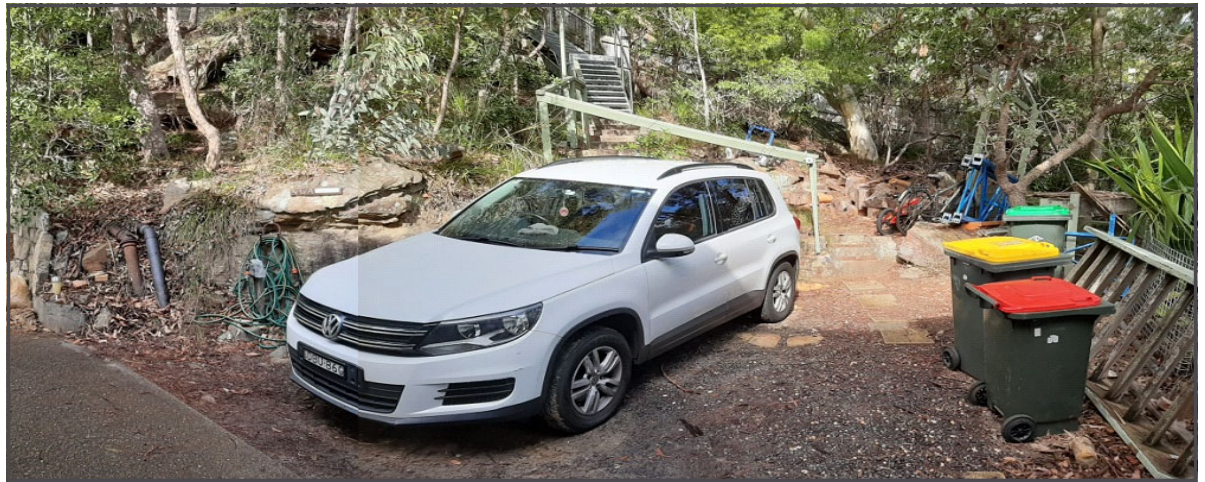
Excavation was required to open up the car space to provide for two car spots and relocation of the services was incorporated into the design (sewer, water, power, communications and drainage).

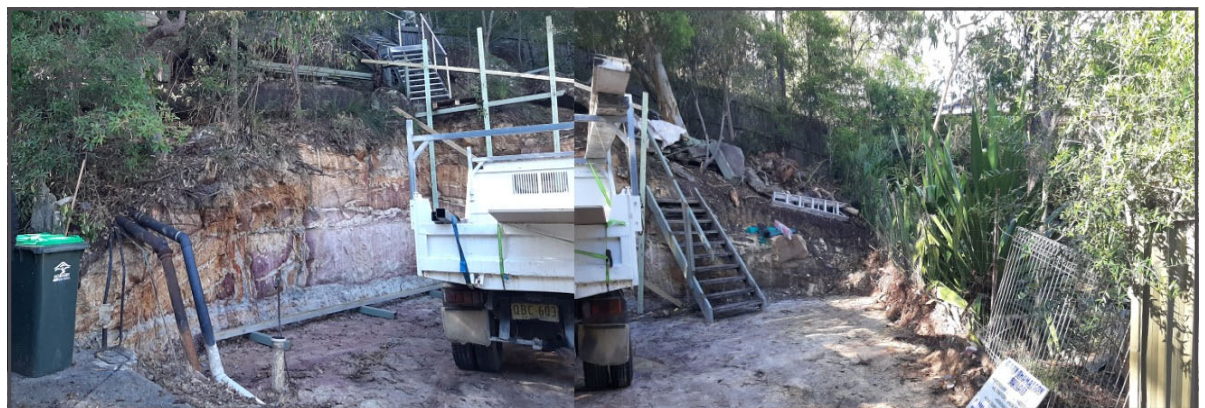
FTS organized to have the exposed rock and services assessed by JK Geotechnics following the exposure of a remnant clay seam within the rock layers.

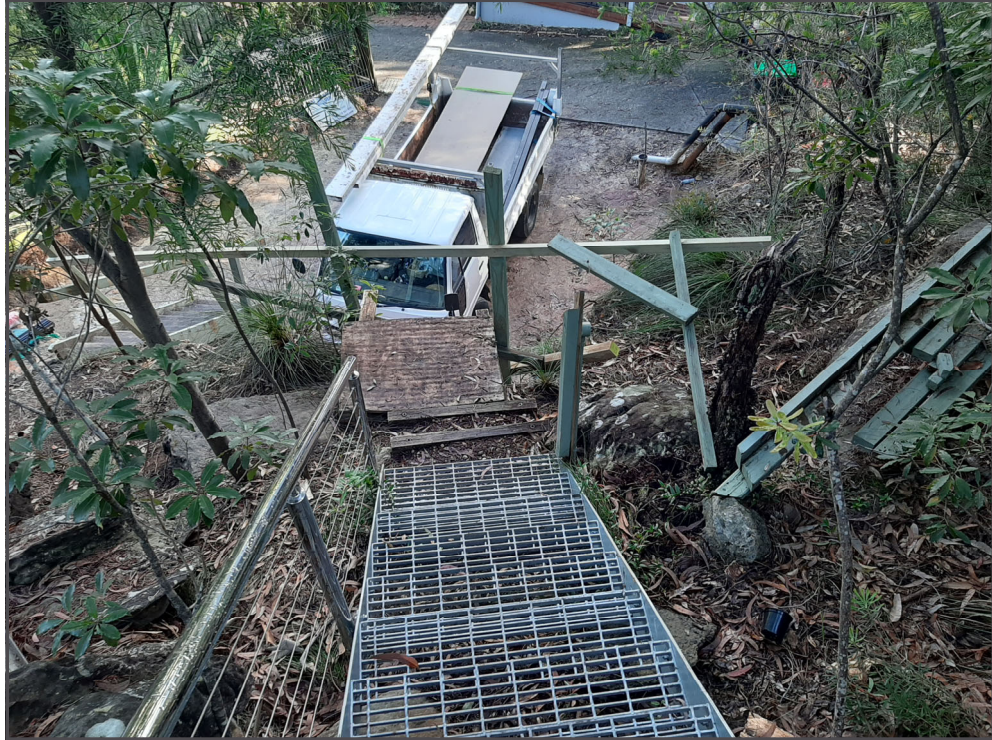
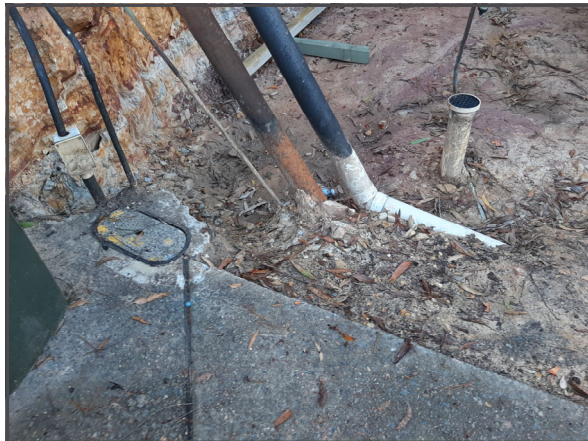
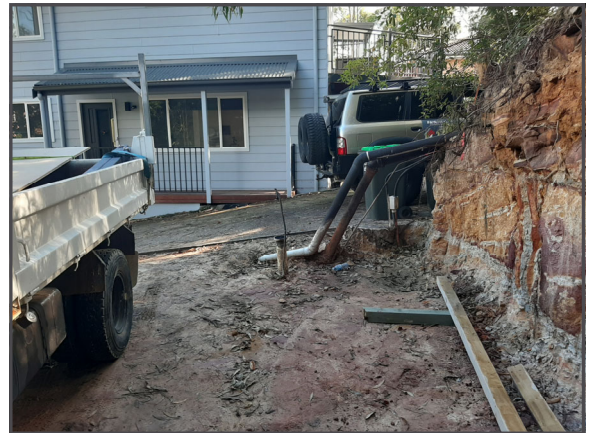
Accessibility constraints and services relocations made for a challenging site design.

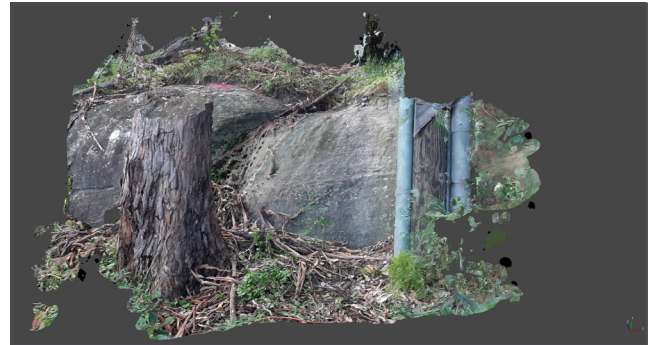
Photogrammetry was used to create 3 dimensional digital models of critical terrain components for analysis during the works. For example, the model was used to obtain profiles and sections rather than multiple visits by the surveyor as the design progressed. This assisted discussions between the consultants about how best to coordinate the design with the site constraints especially during the Covid 19 lockdown.

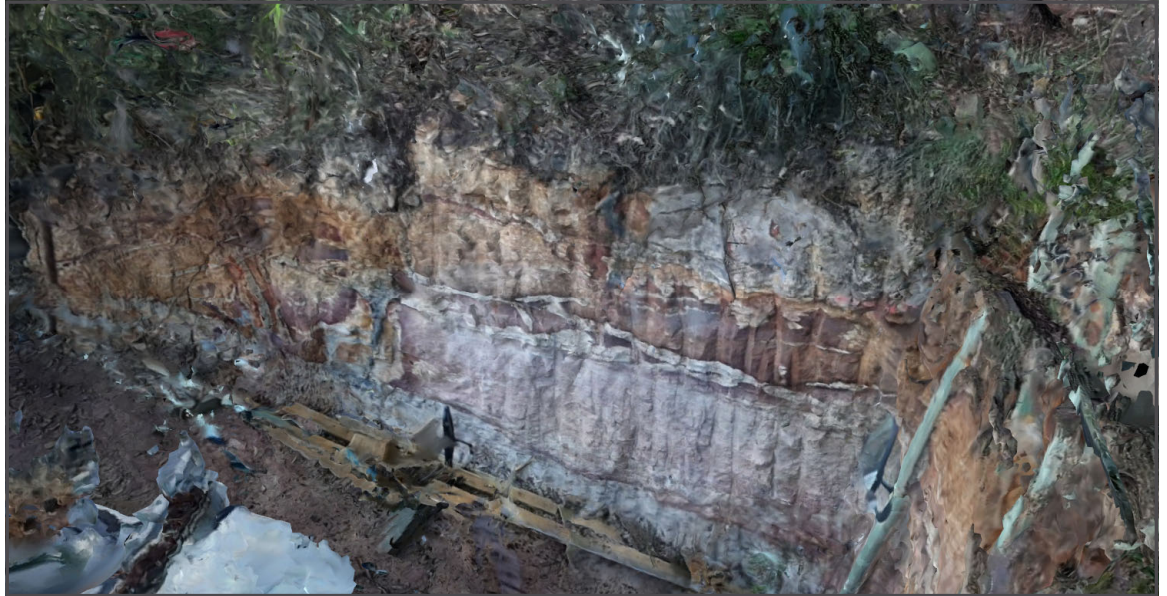
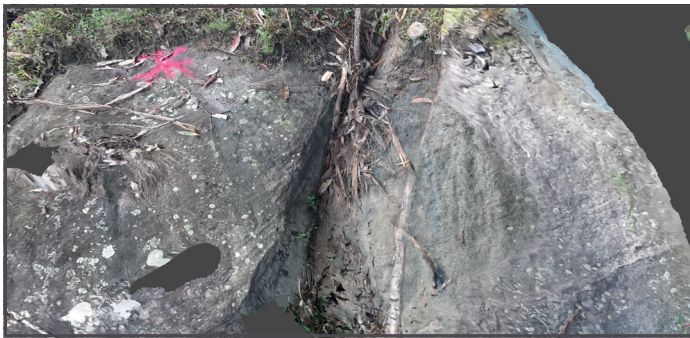
Photogrammetry was used to inspect rock face and check measurement of strata seam thickness.

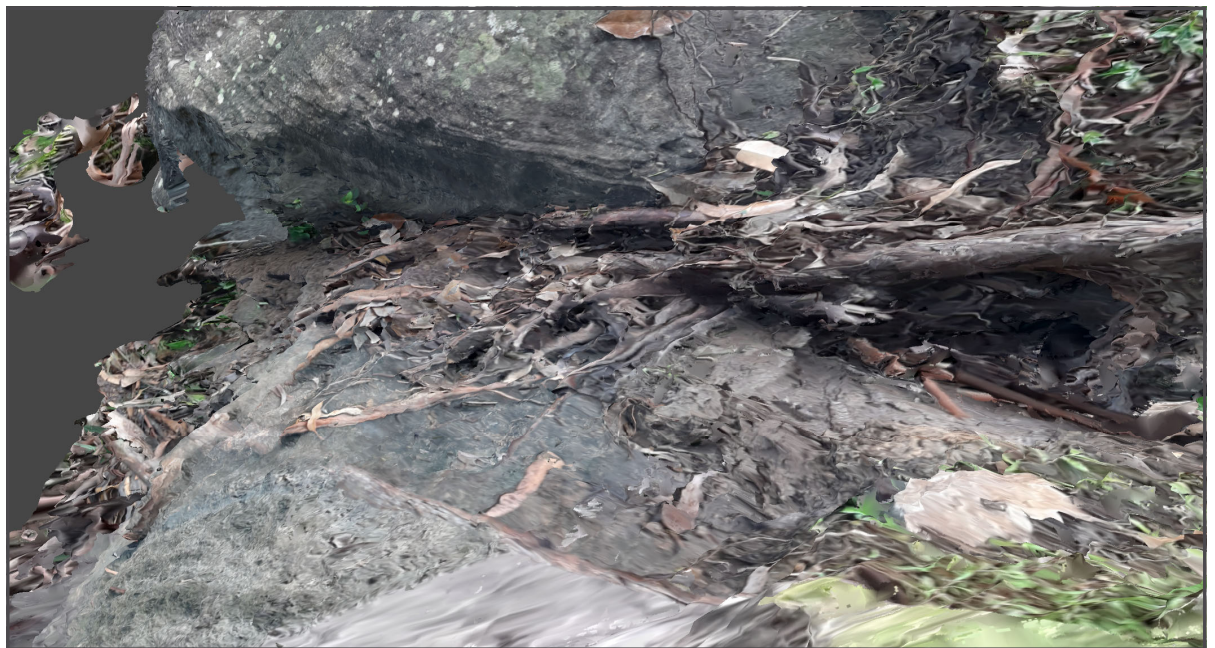
Photogrammetry was used to inspect rock joints to assess root impact and potential destabilization of boulders.
