ROOF FAILURE REMEDIATION - PYMBLE

Date of Project: 18 February 2017

Location:
5 Ward Street
Pymble NSW

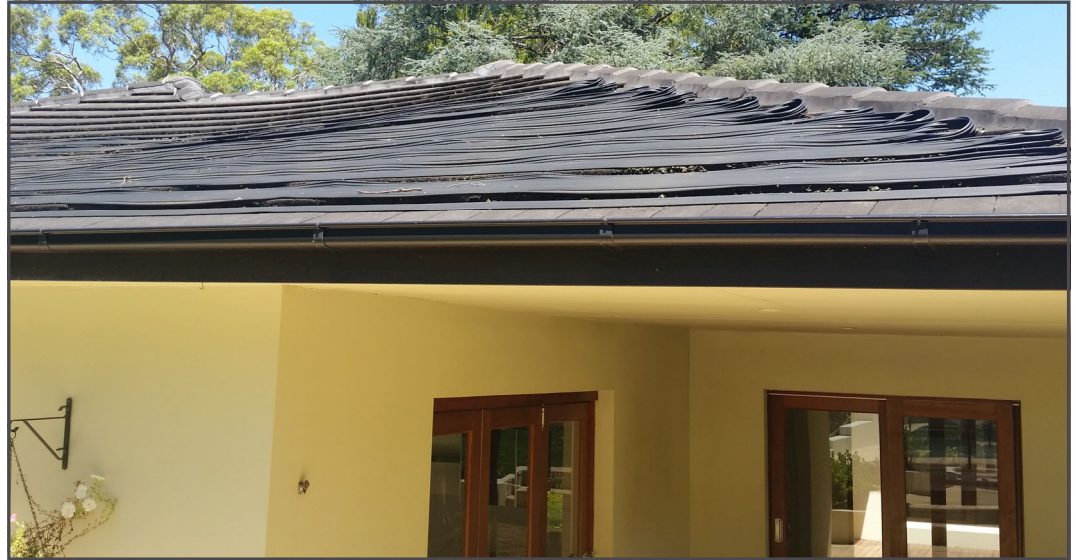
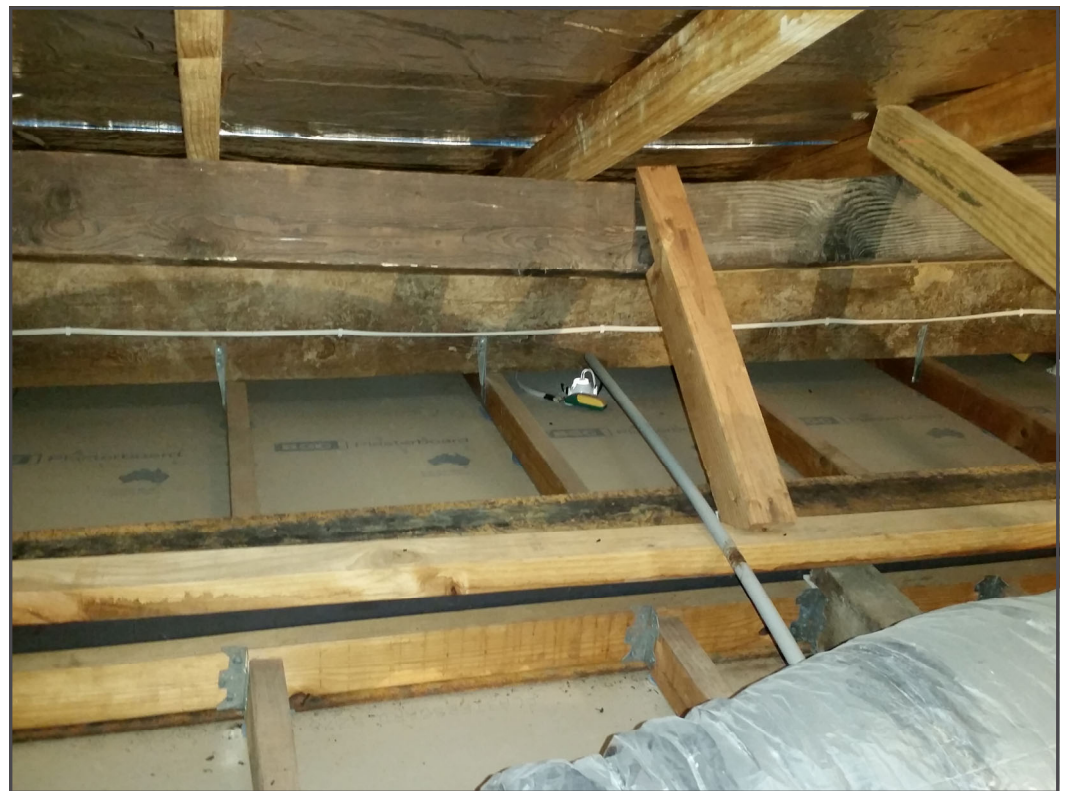
FTS was commissioned to investigate the cause and recommend remedial works by the local council to fix the roof failure of this luxury home in Pymble. Roof, beam hanging beams, strutting beams, underpurlins and some struts were poorly situated causing dislocation, slippage and rotation of beams.

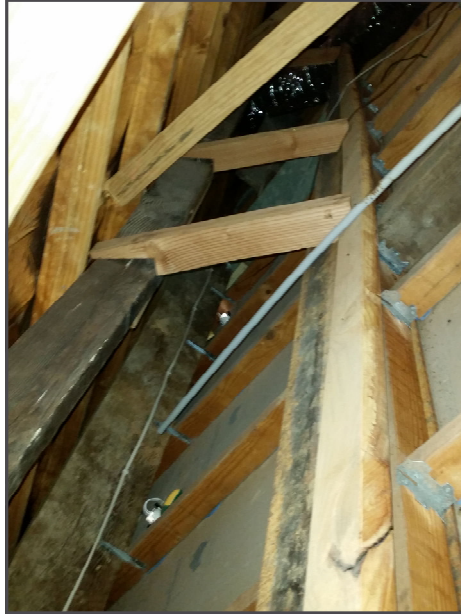
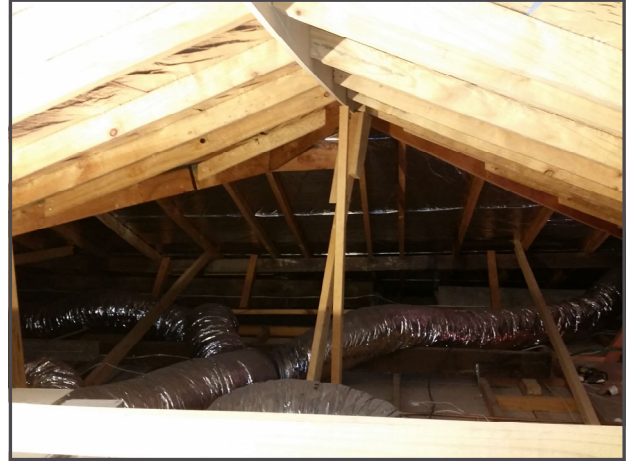
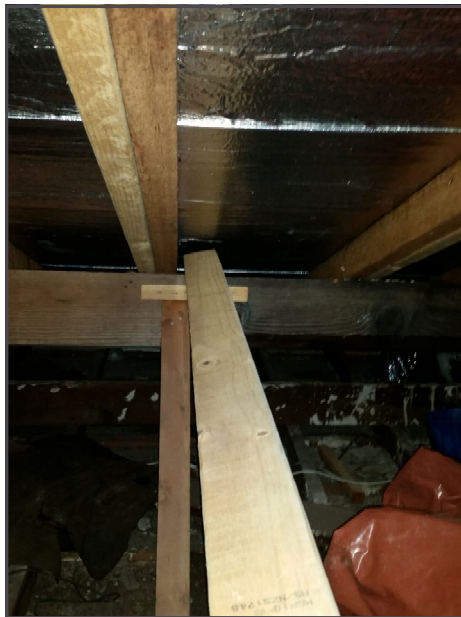
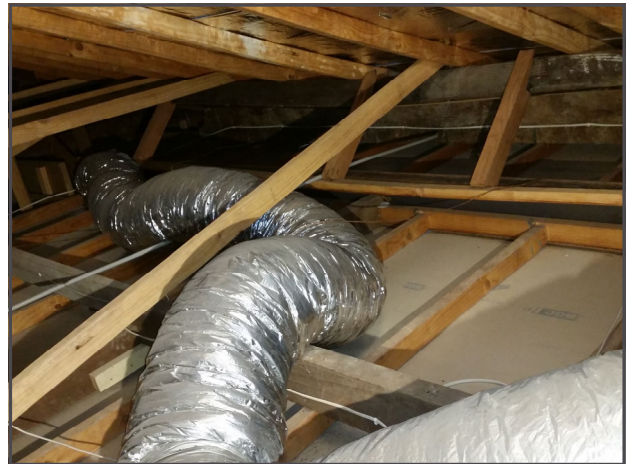
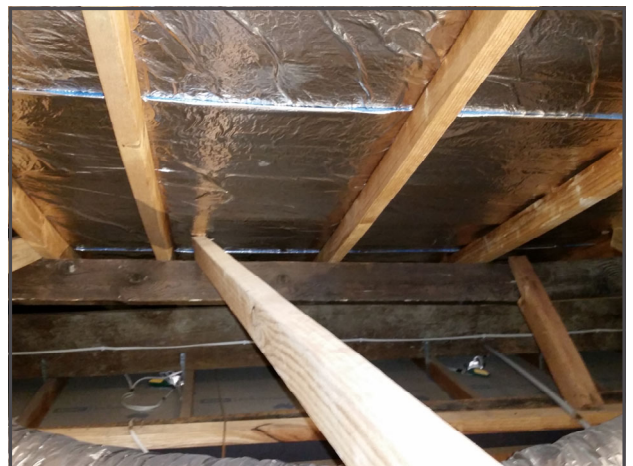
Slippage, poor connections, splitting, dislocation and separations all contributing to the roof sagging and leaking.
